CASE STUDY

H&B MINING - HARD SKIRTS

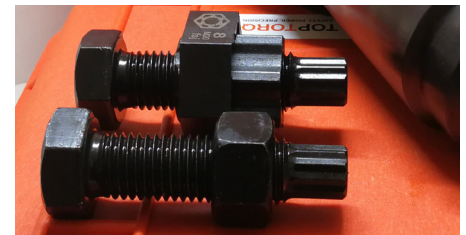
PREVIOUS

NUT	NYLOC NUT
WASHER	FLAT
BOLT	HEX HEAD M20 X 75 - 8.8 - BLK
TOOL METHOD	3/4" IMPACT WRENCH UNCONTROLLED

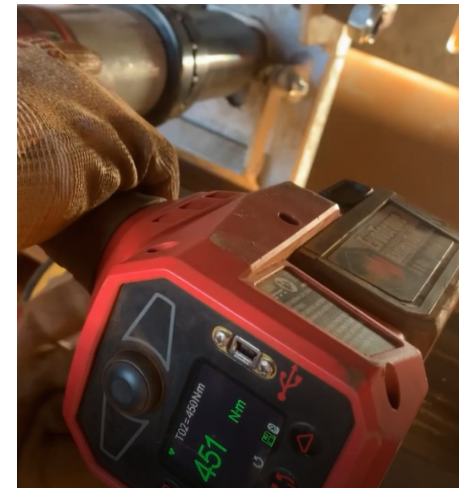
TRIALED: JOINT 1

NUT	M20 SEG NUT - CLASS 8
WASHER	20 MM HDS WASHER (DIN6796)
BOLT	HEX HEAD TOPTORQUE M20 X 75 - 8.8 - BLK
TOOL METHOD	TOPTORQUE ENABLED NORBAR EBT-72-1350 CONTROLLED - 450 NM

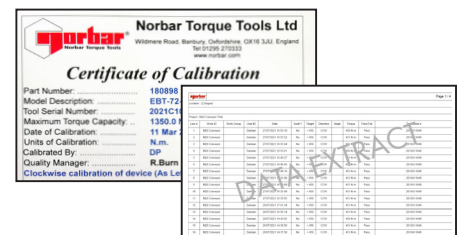
TRIALED: JOINT 2

NUT	M20 HEX - CLASS 8 - STYLE 1
WASHER	20 MM HDS WASHER (DIN6796)
BOLT	HEX HEAD TOPTORQUE M20 X 55 - 8.8 - BLK
TOOL METHOD	TOPTORQUE ENABLED NORBAR EBT-72-1350 CONTROLLED - 440 NM
